# REPORT ON BIO REMEDIATION OF SLUDGE

HINDUSTAN PETROLEUM CORPORATION LTD.,  
VASHI TERMINAL,  
NAVI MUMBAI, INDIA

*PO Number 600024-OP-11588*

Bio-remediation of 120 Kilolitres of sludge, retrieved from tank bottom and stored in pits. To bring down the Oil & Grease percentage to 1%.

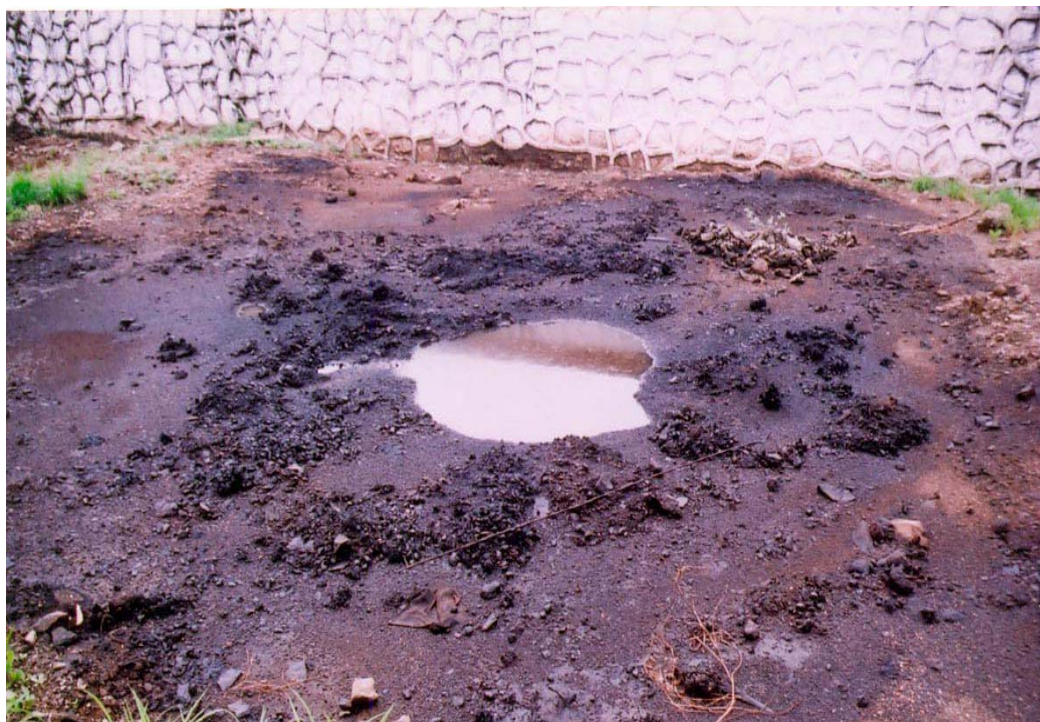
## Sludge pit

Sludge as stored in the pit inside the tank farm.

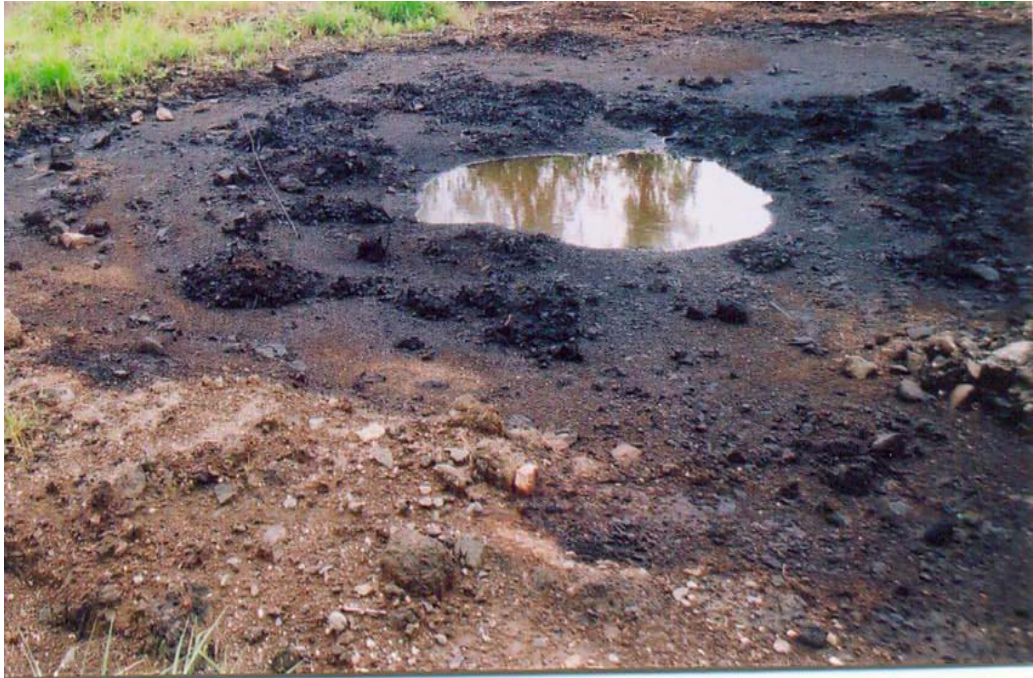
## Sludge pit

Sludge as stored in the pit inside the tank farm.

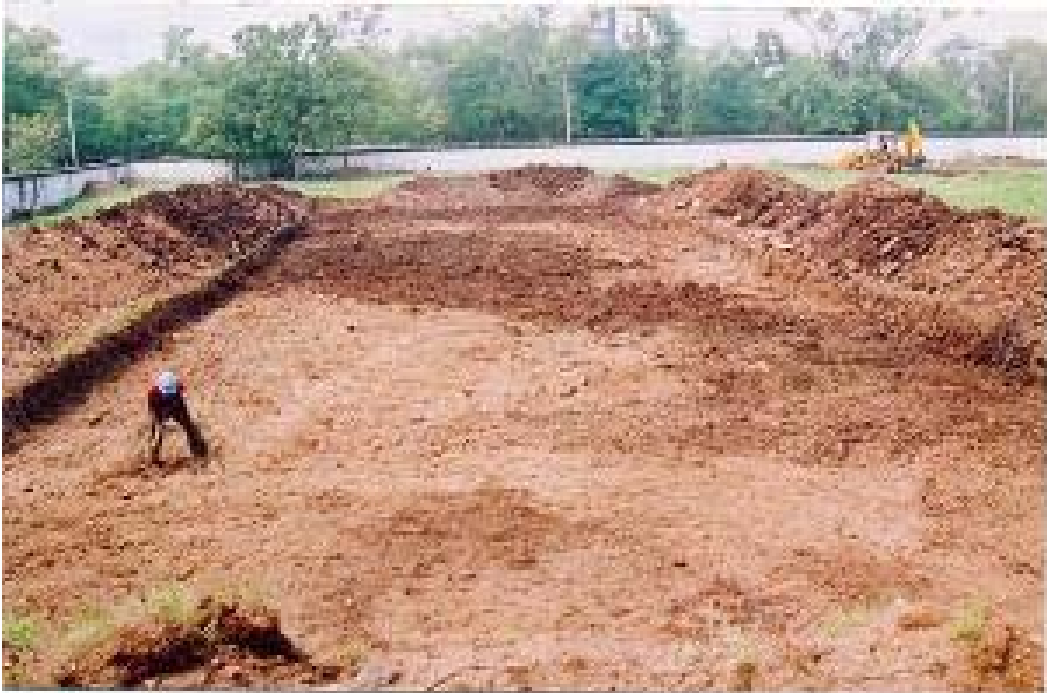
## Excavation of Bioremediation pit

Completion of the excavation work. The Bioremediation pit admeasuring 44.5mtr(L)X15mtr(B)X0.07mtr(D) was made ready.

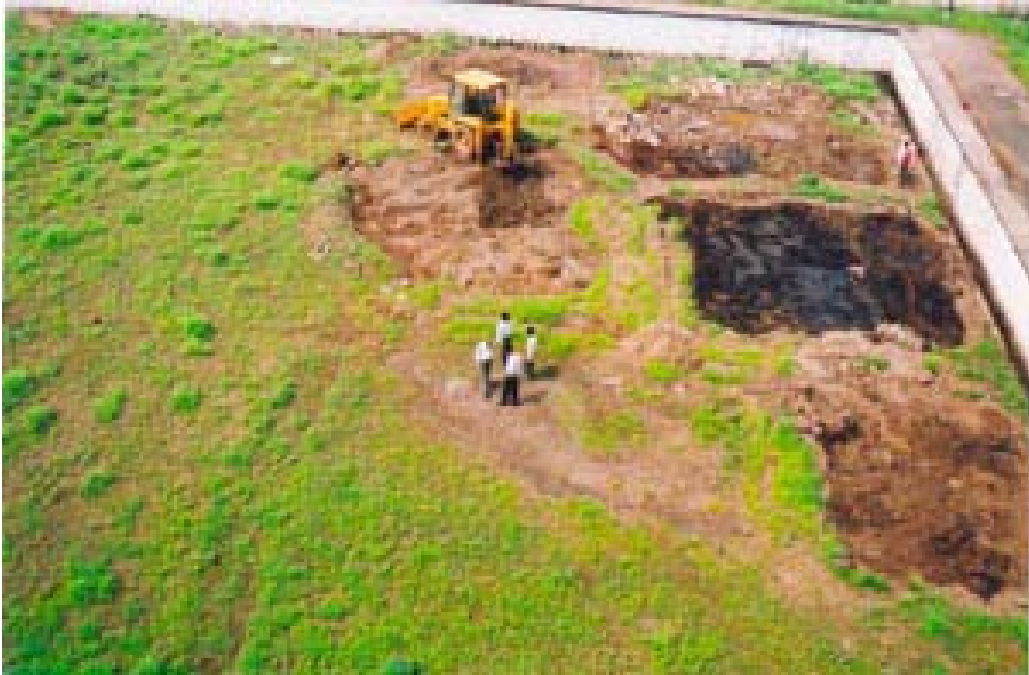
## Transferring sludge

Sludge from the stored pits was transferred into the Bioremediation pit. Quantification of sludge was confirmed by both OFT and HPCL officials.

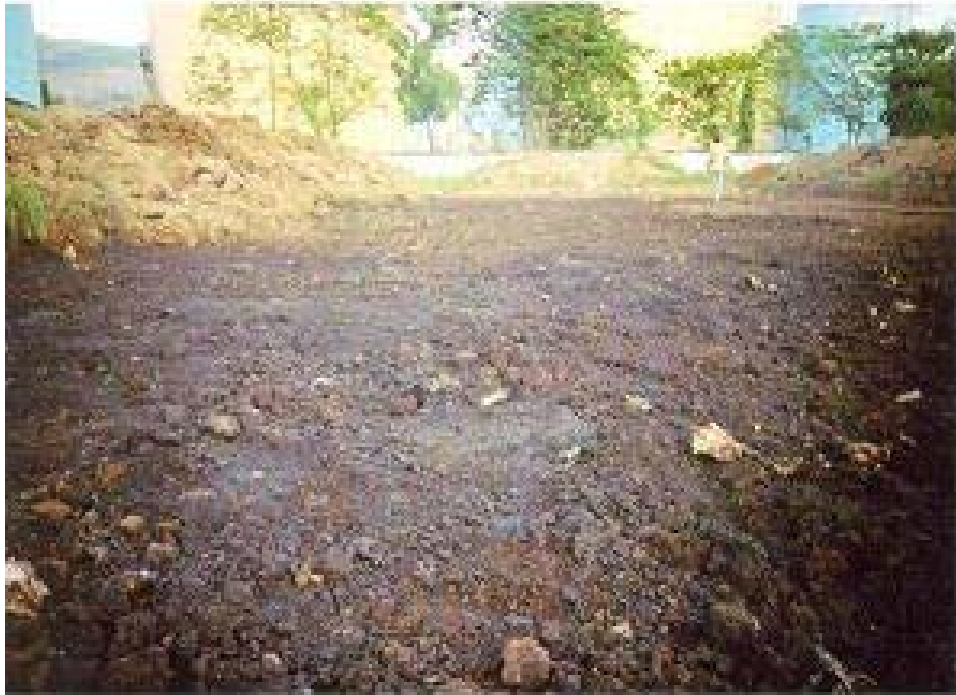
## Levelling of sludge

After the Sludge was dumped into the Bioremeidation pit, levelling has been carried out evenly.

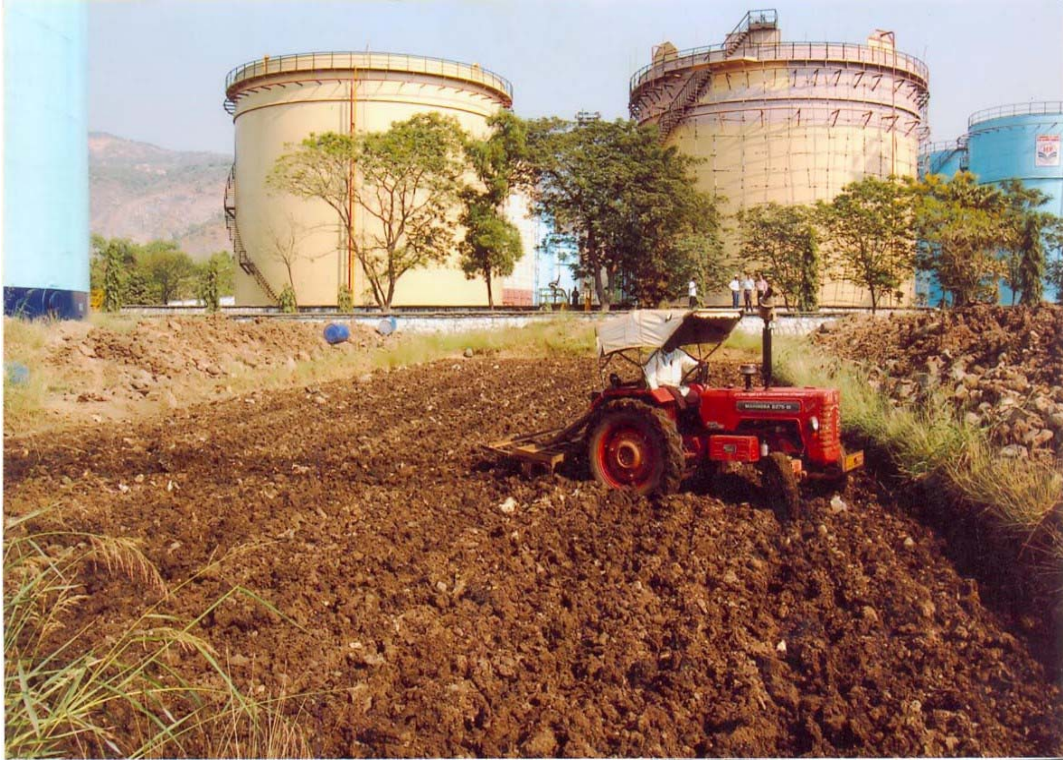
## Tilling sludge soil mixture

Thorough tilling of the Bio remediation pit was carried out so that sludge and soil are completely mixed.

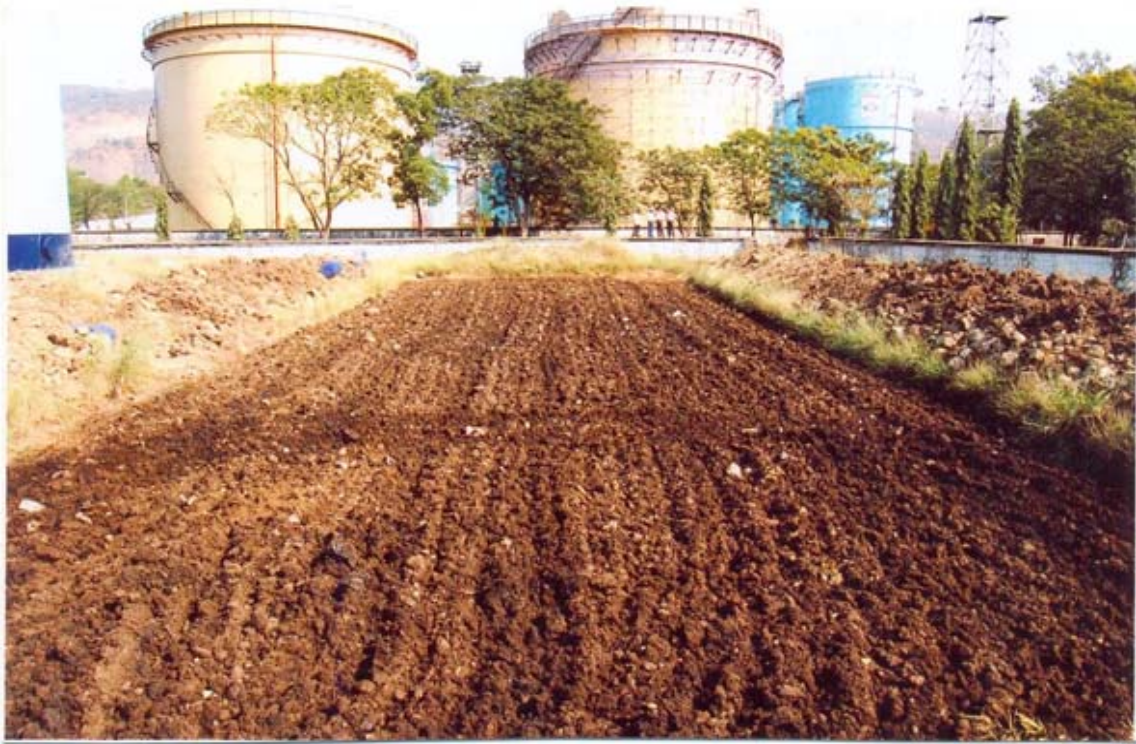
## Sludge ready for the spray

Sludge bed is made ready after tilling for spraying SOLPAR solution

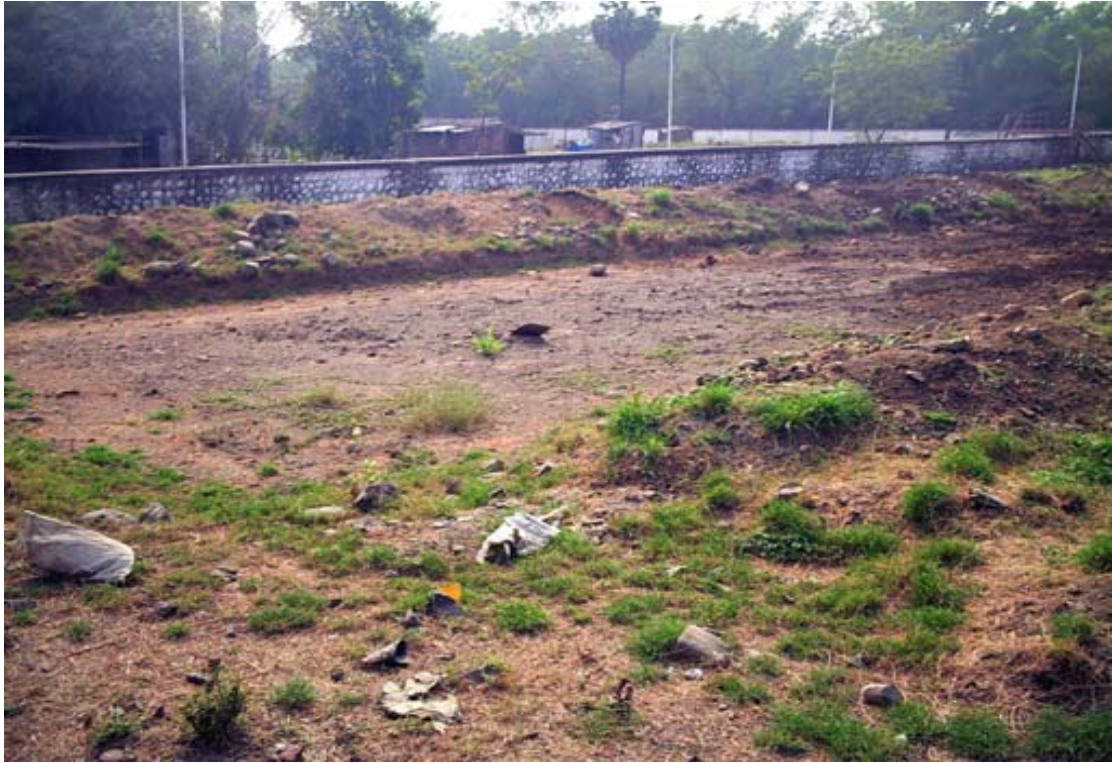
## Side view after the 6th spray

View from the side after completion of the 6th spray

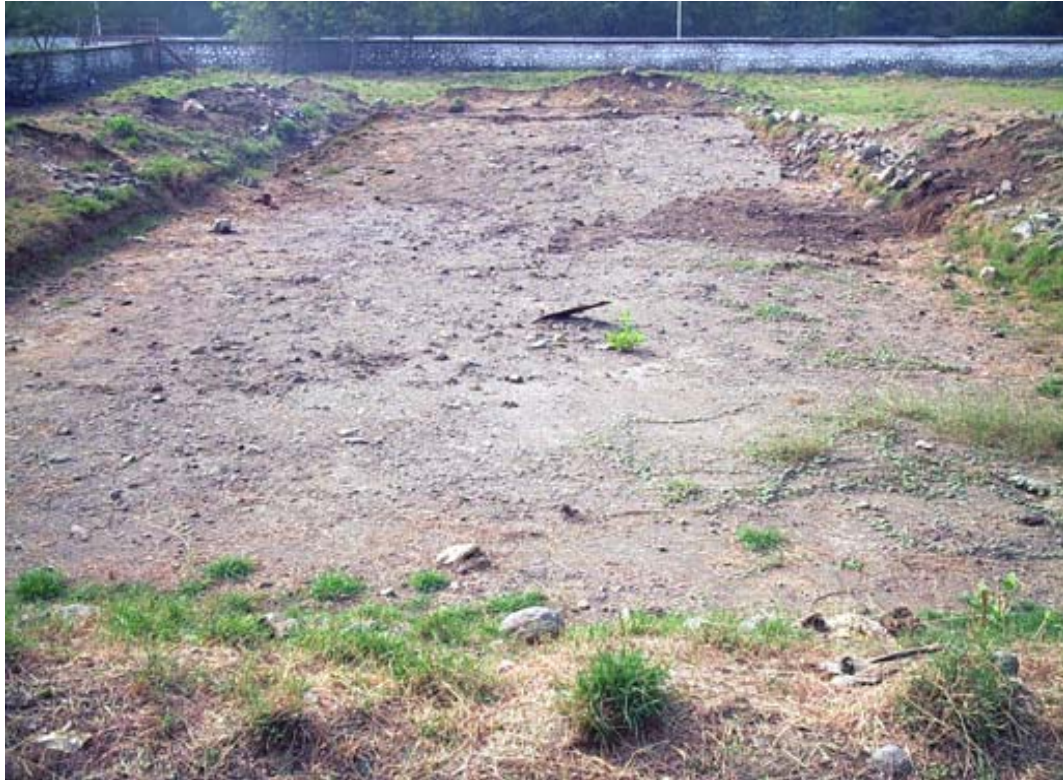
## Wall side view after remediation

Upon completion of the 6th spray, the Bio remediation pit as seen in the wall side view.

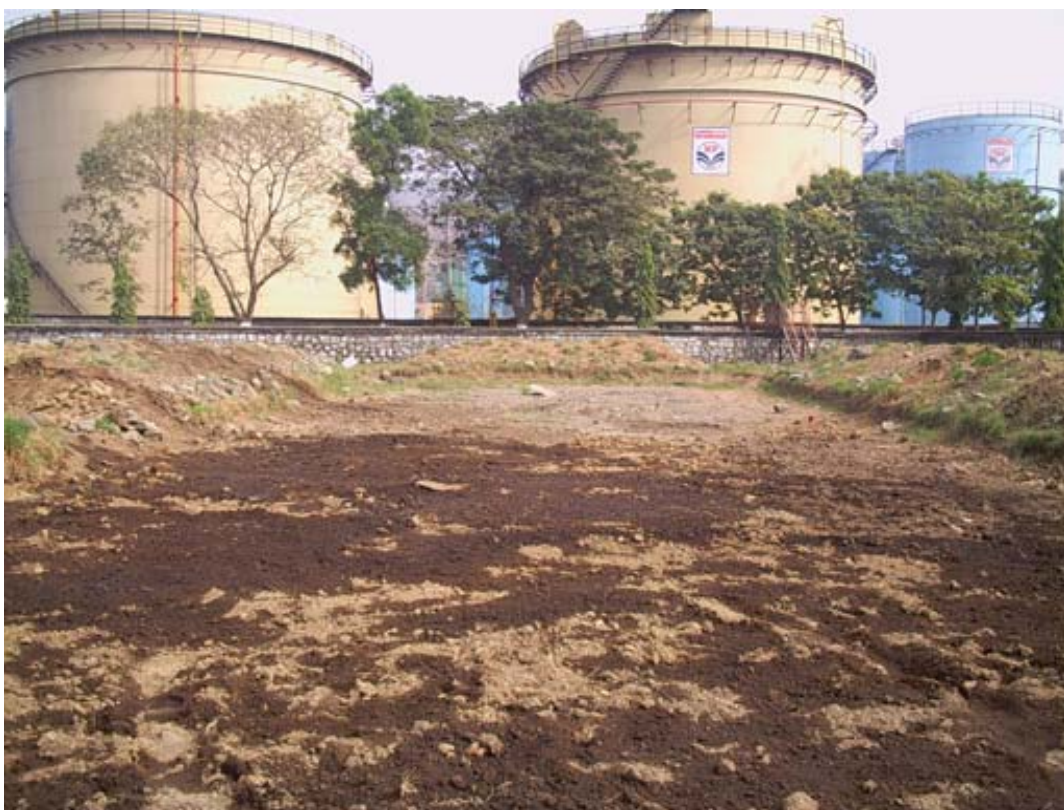
## Tank side view after remediation

The Bio remediation is completed after the 7th spray as seen in the tank view.

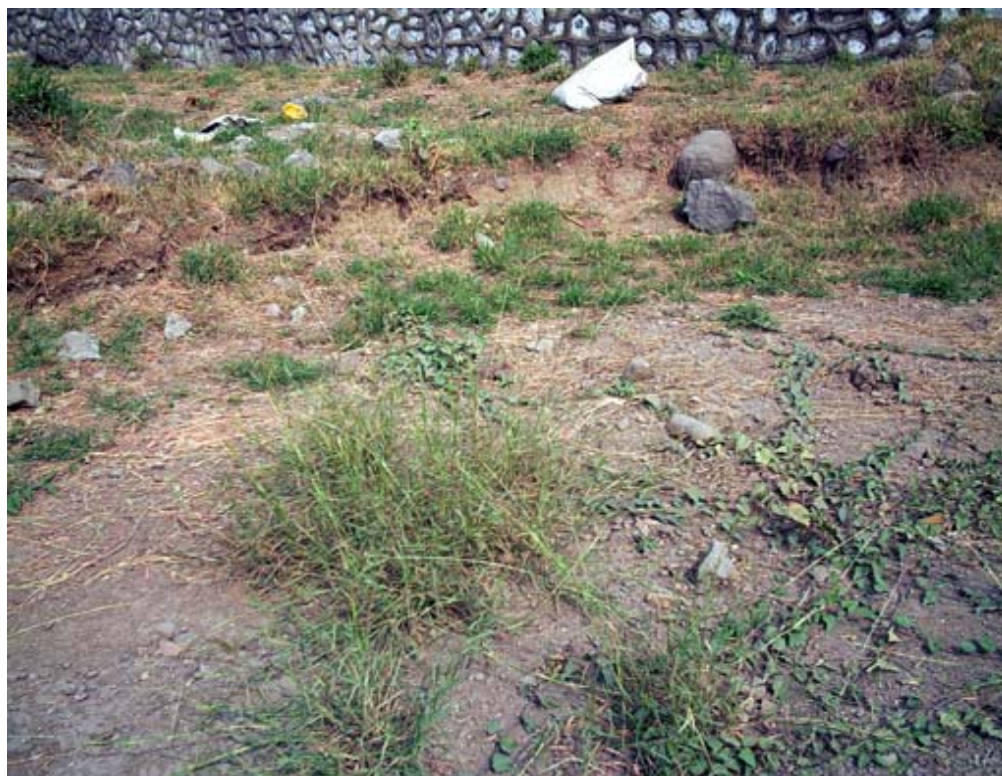
## Plant growth inside the remediation pit

The sludge has been successfully treated. The oil & grease contents have come down to 1%. The sludge has been converted as rich manure and the creeper growth has commenced inside the pit.

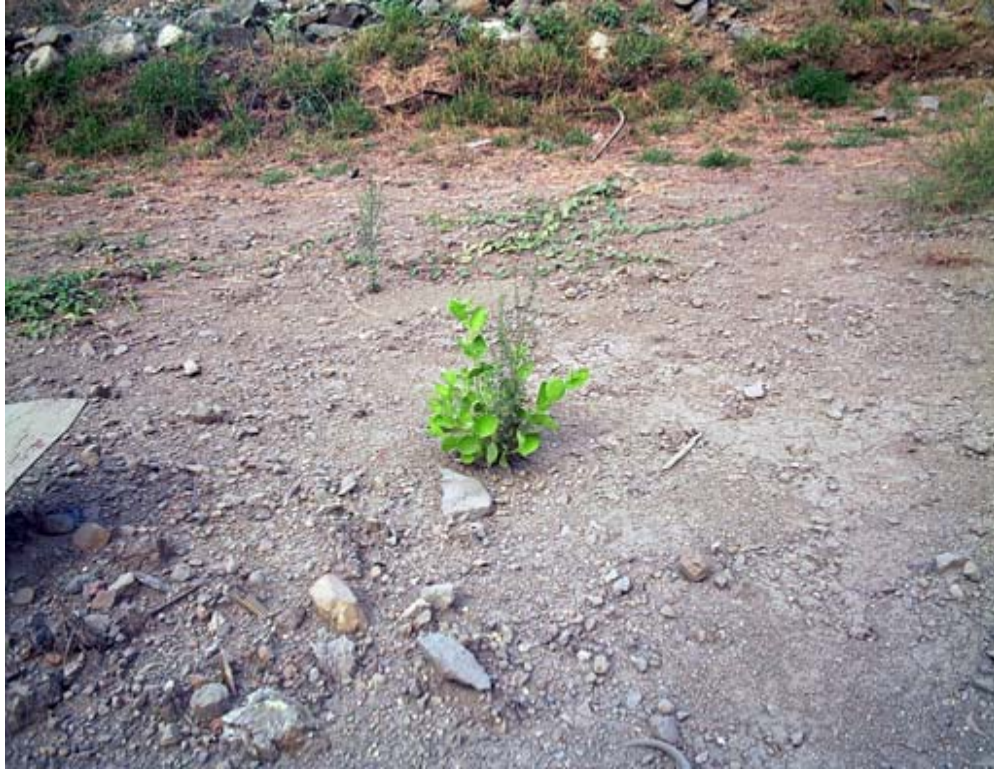
## Close up of the Plant growth

The closeup view of a plant grown inside the Bioremediation pit, after the sludge is converted as carbon rich manure. Laboratory analysis has confirmed the oil & grease percentage is less than 1%.
